Trapco Inspections, LLC.

Home Inspection Report

1 Main Street

Inspected on Monday, October 19, 2020 at 9:00 am

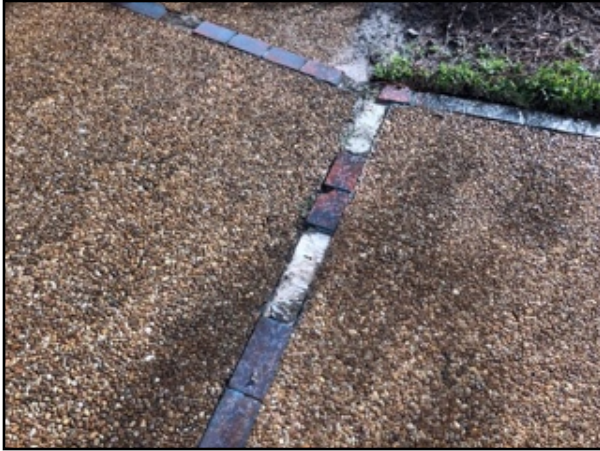
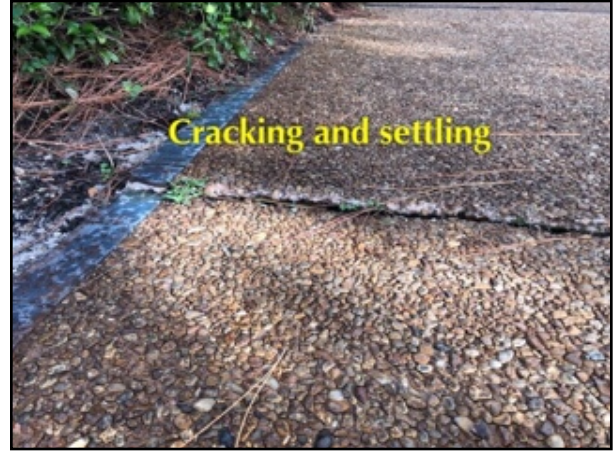
There were some settlement cracks in the driveway. There were also missing and/or damaged decorative tiles between slabs. Fill and monitor to extend driveway lifespan.

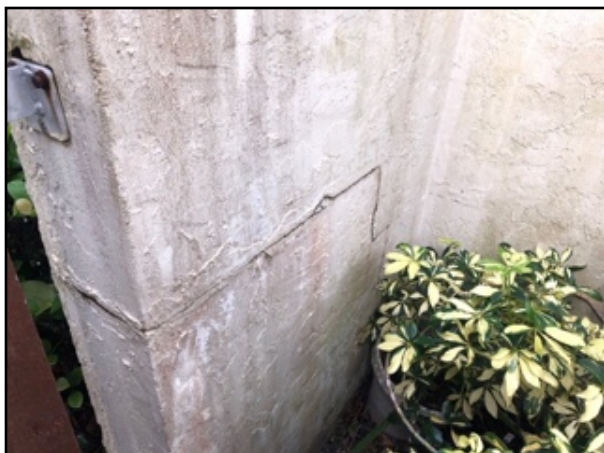
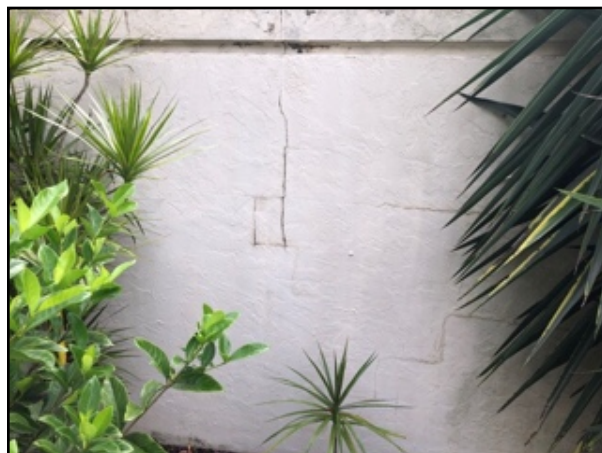
There were some cosmetic hairline cracks on property dividing walls. Recommend refinishing.

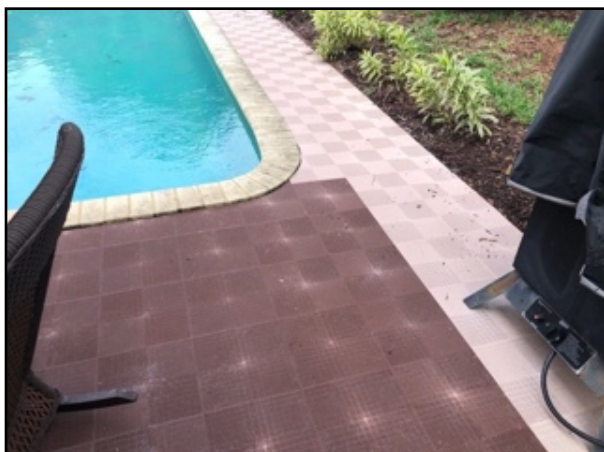
Figure 4-1

The rear patio and area surrounding the pool had plastic flooring tiles covering the concrete deck. Only the plastic tiles could be observed for inspection.

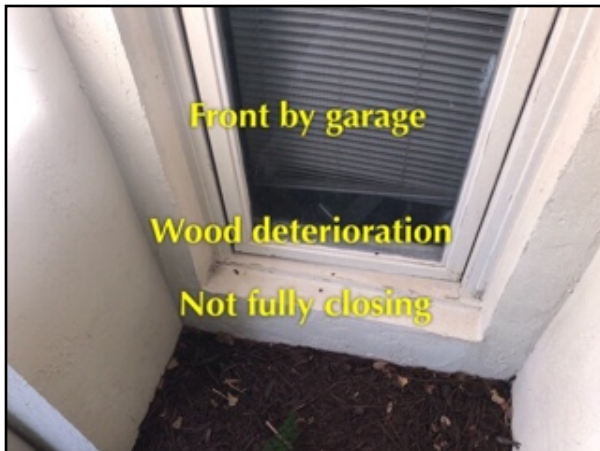
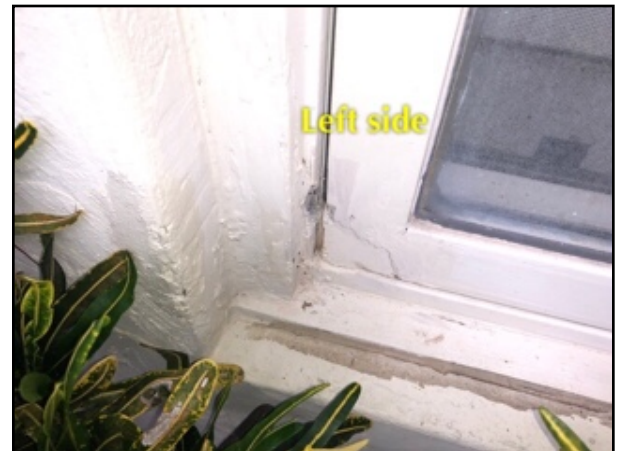
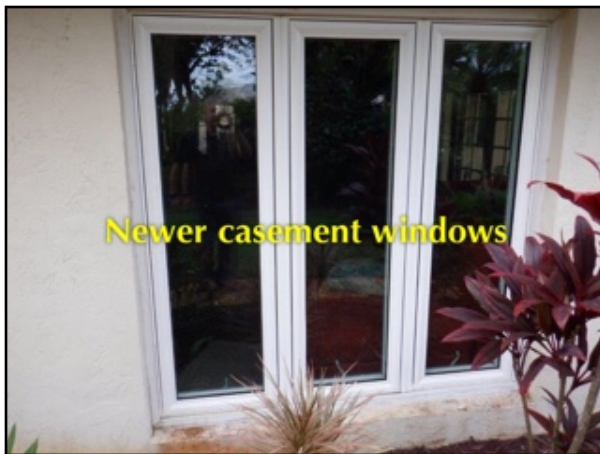
1) In general, wood/ casement windows were in poor condition. Most were missing handles so they could not be tested. There was deterioration to wood framing, etc. The sellers agent limited the inspection time so I was unable to fully inspect the windows. In general, they appeared to all be in disrepair and deteriorated except for the fairly recently replaced right rear casement windows.

In general, wood/ casement windows were in poor condition. Most were missing handles so they could not be tested. There was deterioration to wood framing, etc. The sellers agent limited the inspection time so I was unable to fully inspect the windows. In general, they appeared to all be in disrepair and deteriorated except for the fairly recently replaced right rear casement windows.

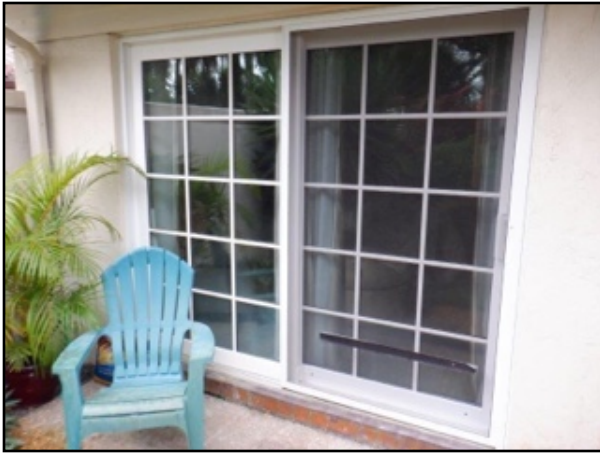
Figure 7-1

There was one hurricane protected right rear slider.

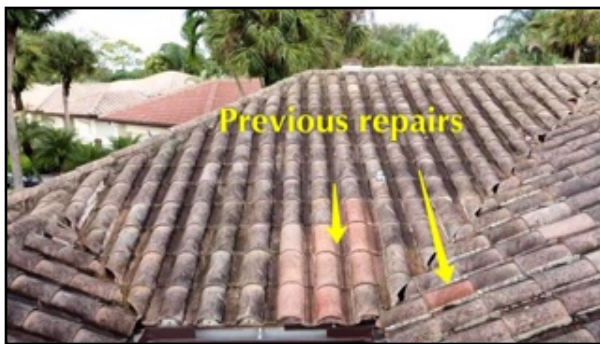
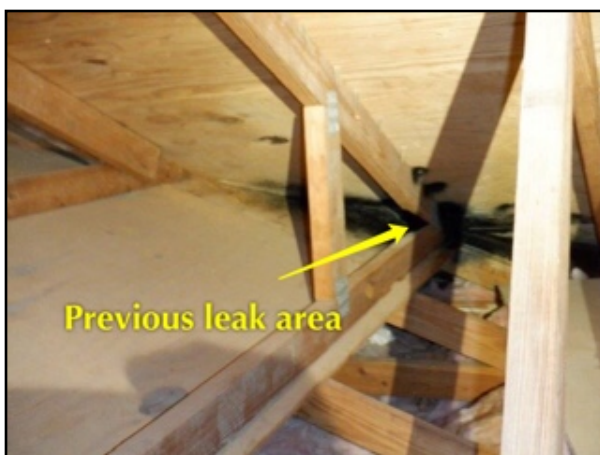
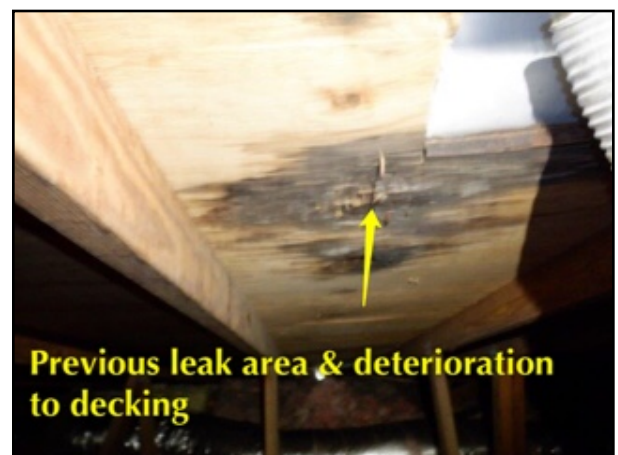
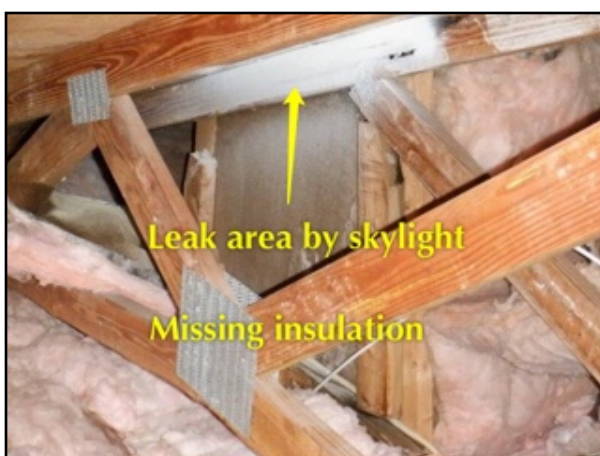
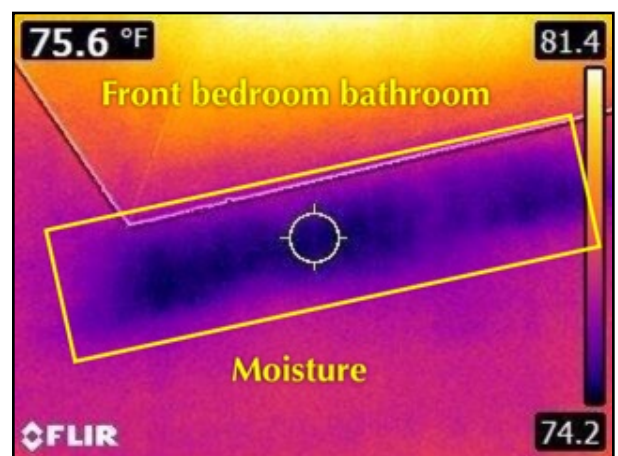
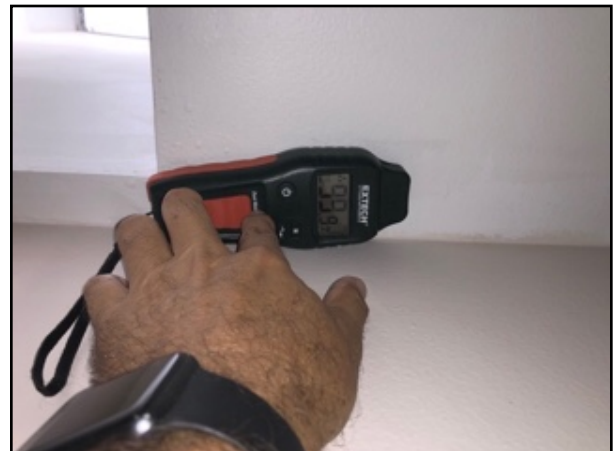
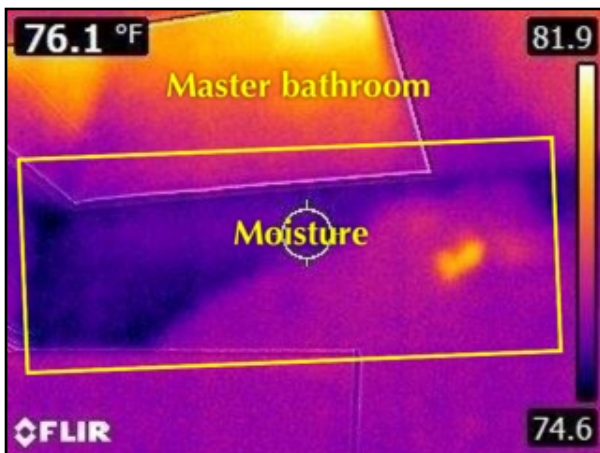
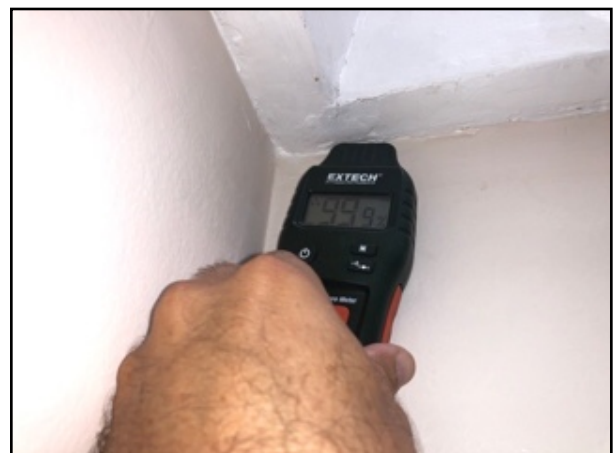
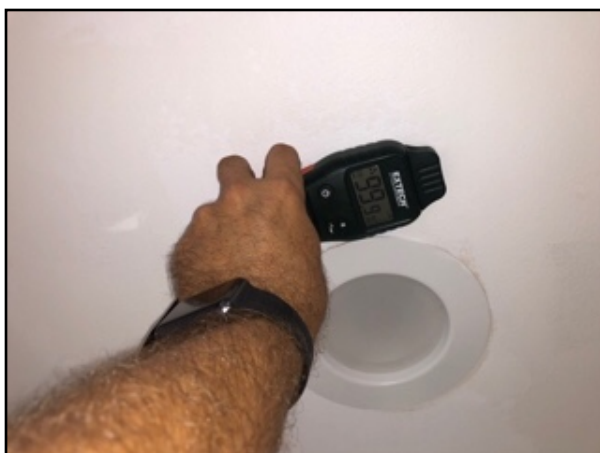
2) The average life expectancy of a concrete tile roof in South Florida is 18- 25 years. This roof has far exceeded average lifespan, had multiple previous repairs and was actively leaking at skylights in bathrooms. There was also staining to attic sheathing and trusses. There was significant deterioration to about a 3'x3' section by the rear roof vent due to a previous leak though it was dry at time of inspection. Recommend further evaluation by a licensed roofer for replacement options.

The average life expectancy of a concrete tile roof in South Florida is 18- 25 years. This roof has far exceeded average lifespan, had multiple previous repairs and was actively leaking at skylights in bathrooms. There was also staining to attic sheathing and trusses. There was significant deterioration to about a 3'x3' section by the rear roof vent due to a previous leak though it was dry at time of inspection. Recommend further evaluation by a licensed roofer for replacement options.

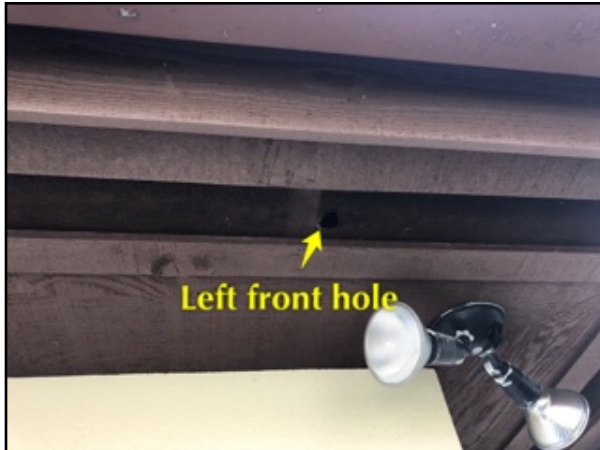
Figure 13-1

3) There was a hole in soffit screening that should be repaired to prevent pests from entering the attic space.

There was a hole in soffit screening that should be repaired to prevent pests from entering the attic space.

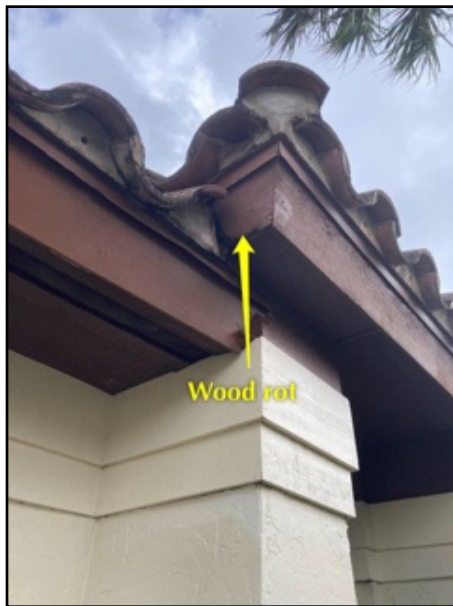
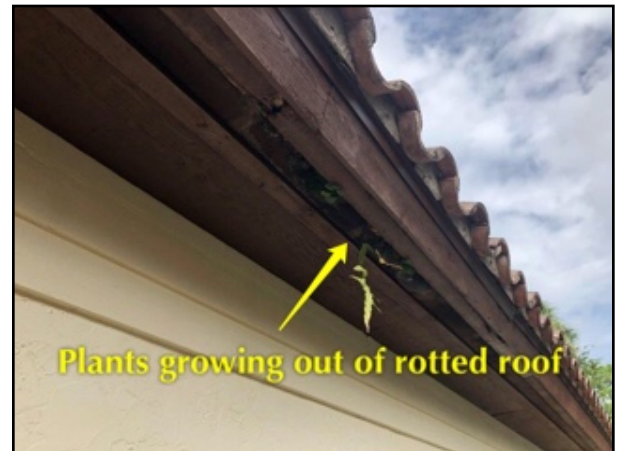
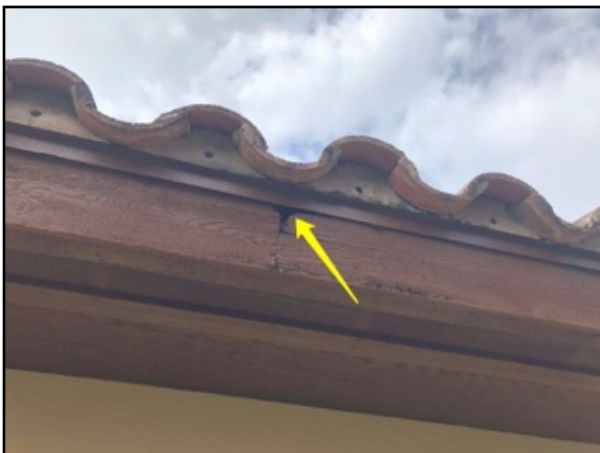
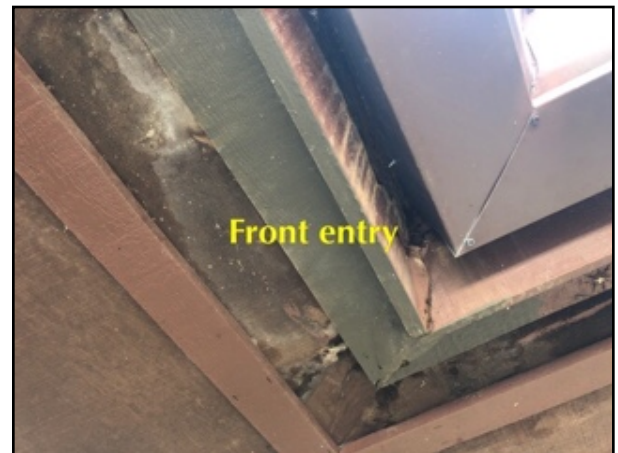
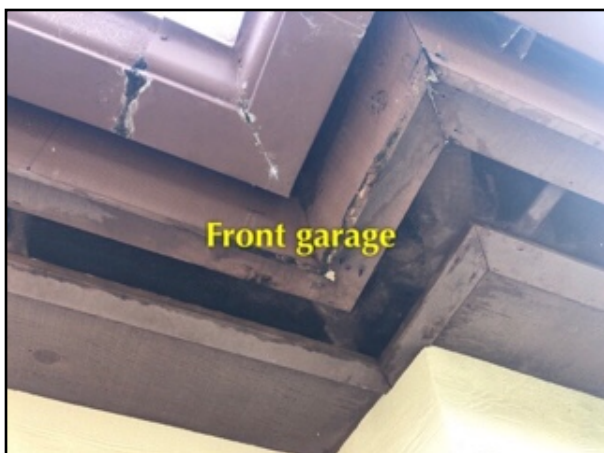
4) Damage to wood fascia showed that flashing and underlayment had failed at the bottom of the roof in a number of areas. There was significant wood rot to fascia. All flashing and deteriorated fascia should be replaced at time of re-roof.

Damage to wood fascia showed that flashing and underlayment had failed at the bottom of the roof in a number of areas. There was significant wood rot to fascia. All flashing and deteriorated fascia should be replaced at time of re-roof.

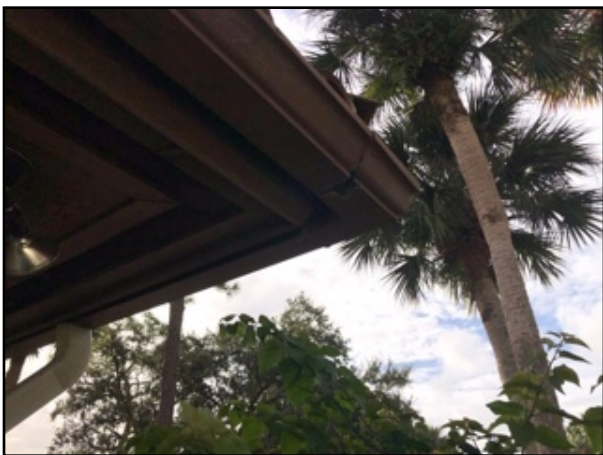
Figure 15-1

5) The partial gutter system showed it was leaking at joints. Recommend replacing gutters at time of re-roof.

The partial gutter system showed it was leaking at joints. Recommend replacing gutters at time of re-roof.

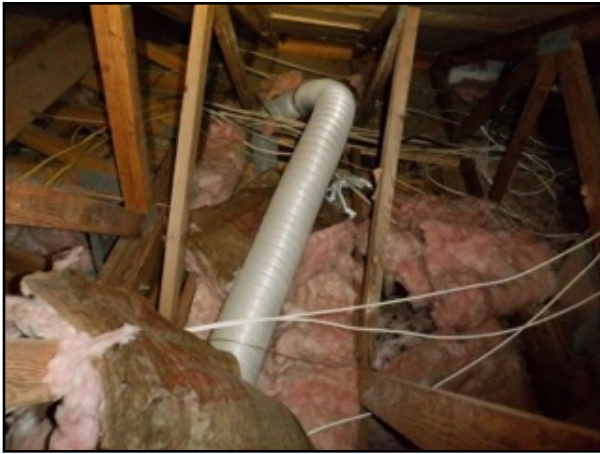
Figure 18-1

There was a good deal of displaced insulation that should be reinstalled in the attic.

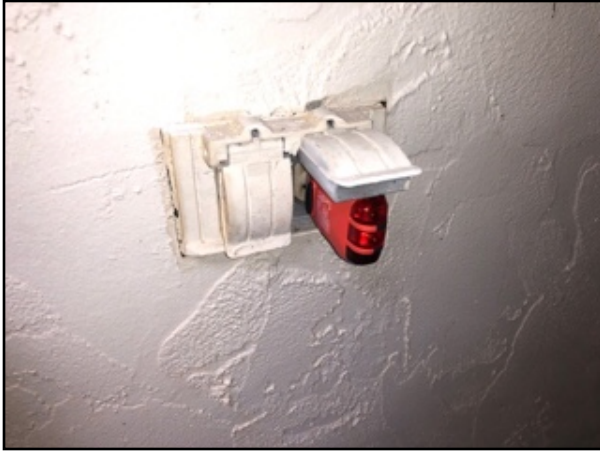
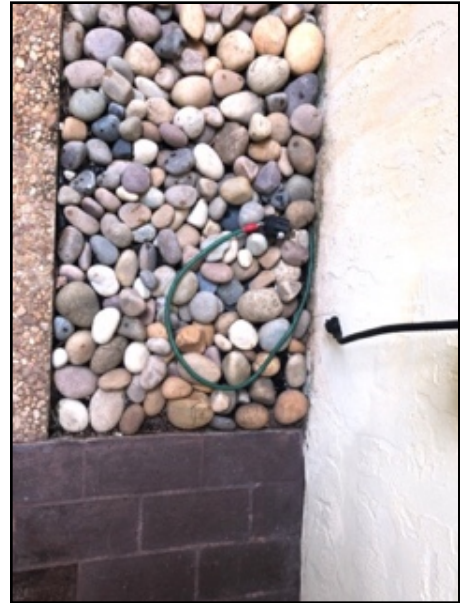
8) Exterior outlets, except for 1 by pool, did not have GFCI protection. This may be due to a failed GFCI breaker in the service panel. Have an electrician evaluate all exterior outlets to make sure they are protected.

Exterior outlets, except for 1 by pool, did not have GFCI protection. This may be due to a failed GFCI breaker in the service panel. Have an electrician evaluate all exterior outlets to make sure they are protected.

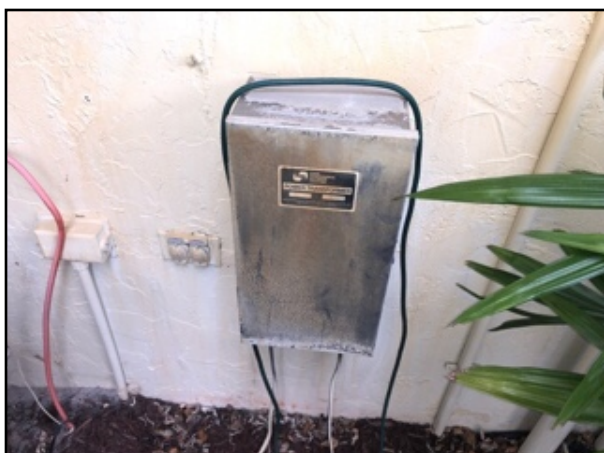
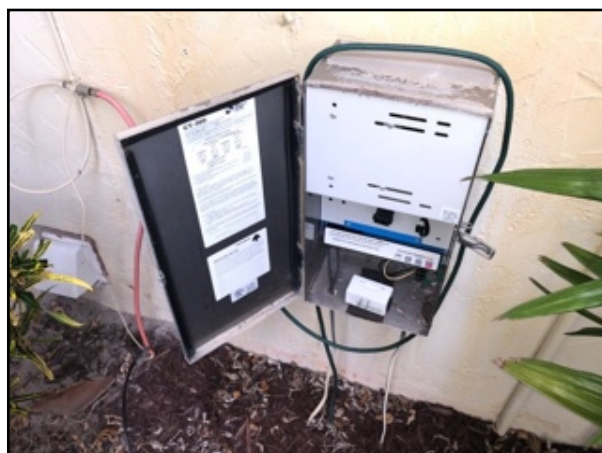
9) There was an unplugged transformer on the left side of the home for landscape lighting. It was plugged in and no working lights were found in the landscape. Recommend further evaluation for repair, replacement or removal.

There was an unplugged transformer on the left side of the home for landscape lighting. It was plugged in and no working lights were found in the landscape. Recommend further evaluation for repair, replacement or removal.

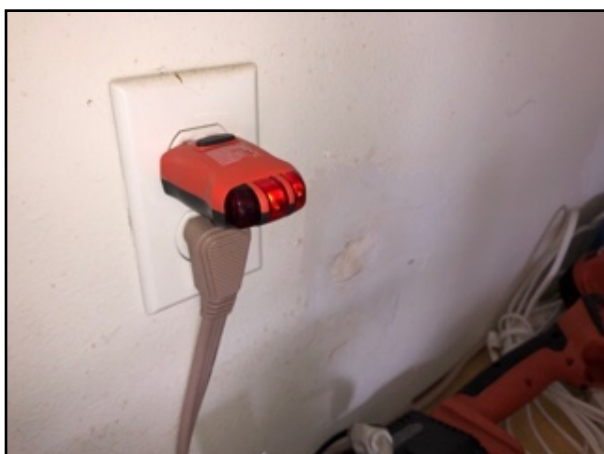
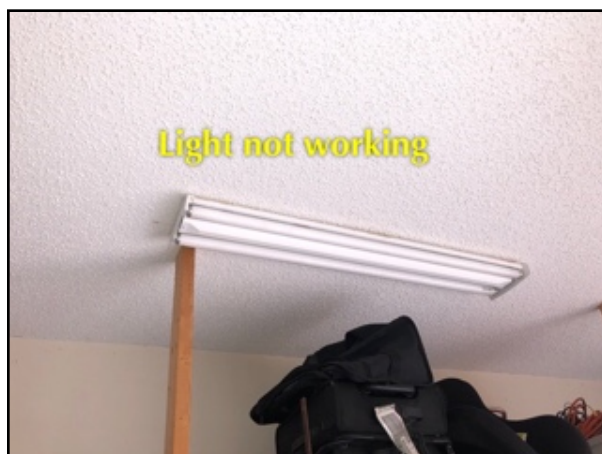
10) There was no GFCI protection for outlets in the garage. There was a GFCI breaker in the panel that was not working so possibly when replaced the protection for garage outlets will be restored. Recommend further evaluation and repair by a licensed electrician.

There was no GFCI protection for outlets in the garage. There was a GFCI breaker in the panel that was not working so possibly when replaced the protection for garage outlets will be restored. Recommend further evaluation and repair by a licensed electrician.

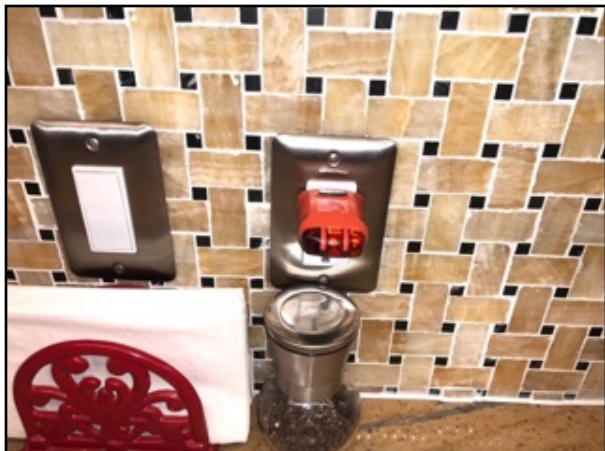
Figure 27-1

11) Outlets next to the kitchen sink were not GFCI protected. Recommend an electrician correct for safety.

Outlets next to the kitchen sink were not GFCI protected. Recommend an electrician correct for safety.

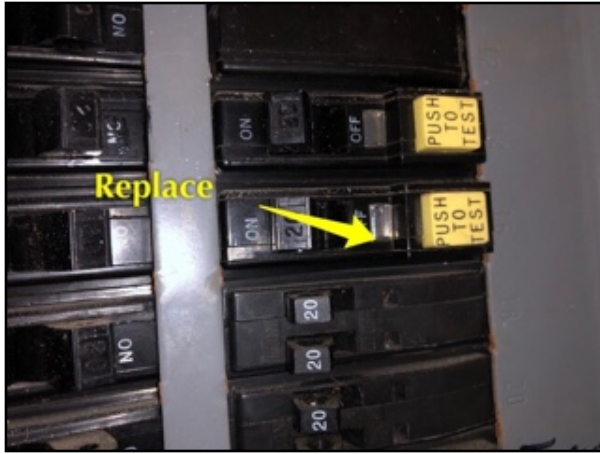
Figure 28-1

12) Replace GFCI breaker in #16. It did not trip when tested.

Replace GFCI breaker in #16. It did not trip when tested.

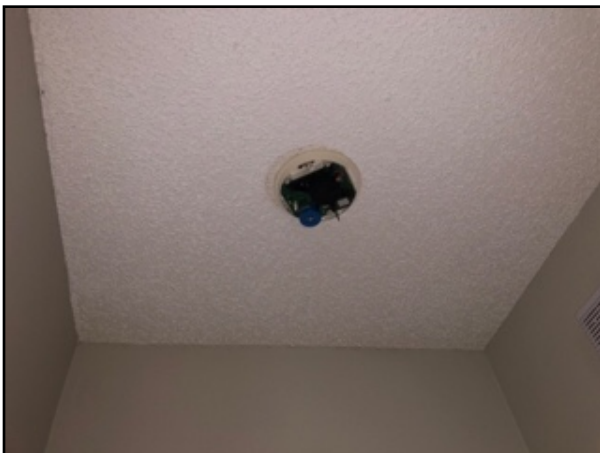
Figure 29-1

13) The smoke detectors were older, missing or not working, and should be replaced for fire safety. Recommend installing enough 10 year lithium back up battery smoke detectors and carbon monoxide detectors for today's standards. Check with local ordinance for proper coverage.

The smoke detectors were older, missing or not working, and should be replaced for fire safety. Recommend installing enough 10 year lithium back up battery smoke detectors and carbon monoxide detectors for today's standards. Check with local ordinance for proper coverage.

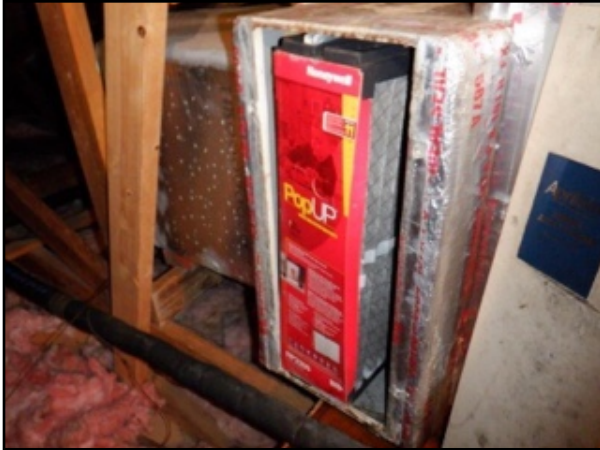
Figure 34-1

The attic installed filter appeared to be the wrong size. Recommend installing the proper size.

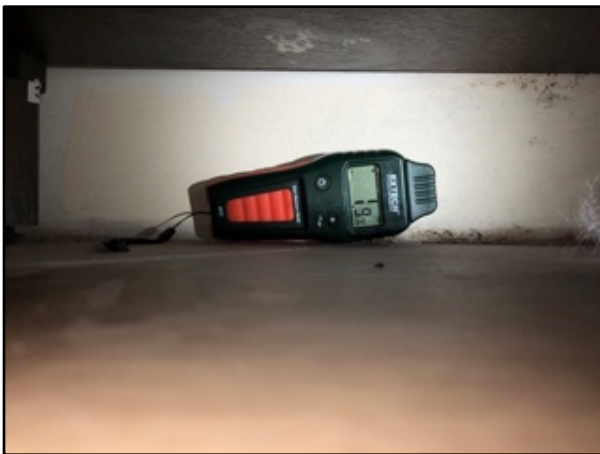
Figure 49-1

There was some staining to the wall underneath the sink but it was dry at time of inspection. Likely from a previous leak.

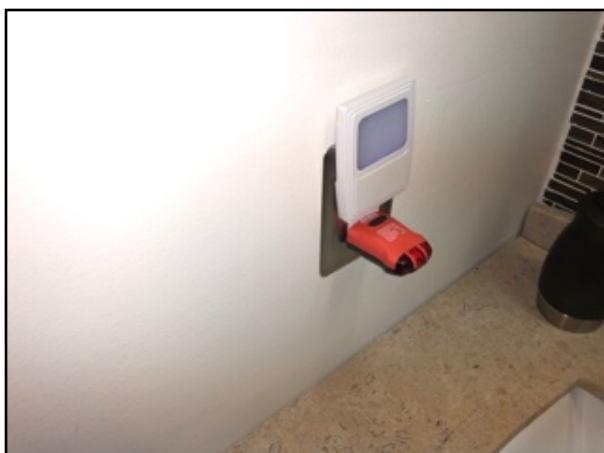
Figure 52-1

18) GFCI's (Ground Fault Circuit Interrupters) are safety devices for use in wet locations. This home had no GFCI protection in the front bedroom and hall bathrooms. This may be because of the GFCI breaker in the panel that did not trip when tested. Recommend further evaluation and repair by an electrician.

There was no GFCI protection for outlet in the hall bath. Possibly tied to the nonworking GFCI outlet in the breaker panel.

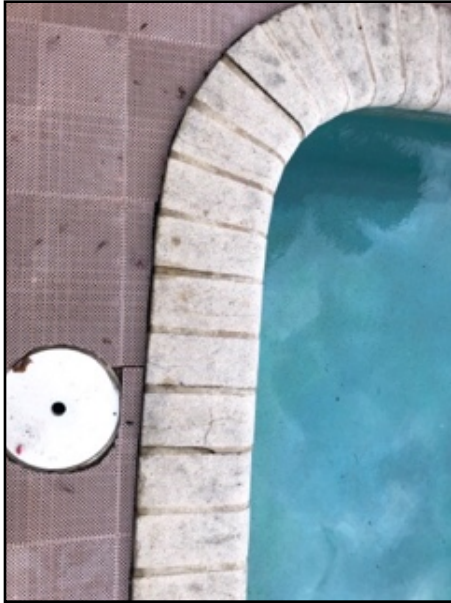
Figure 56-1

21) There were some damaged coping tiles that should be replaced.

There were some damaged coping tiles that should be replaced.

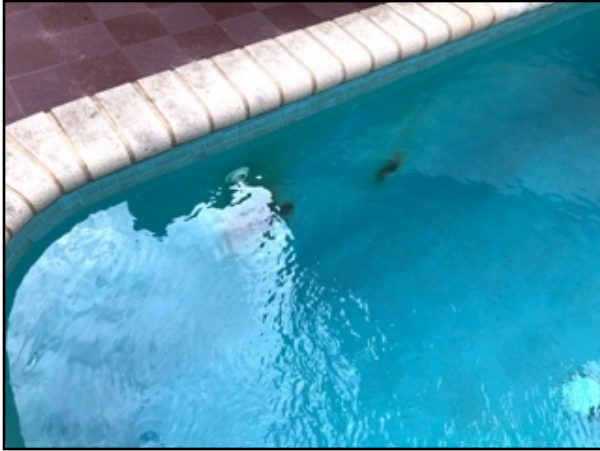
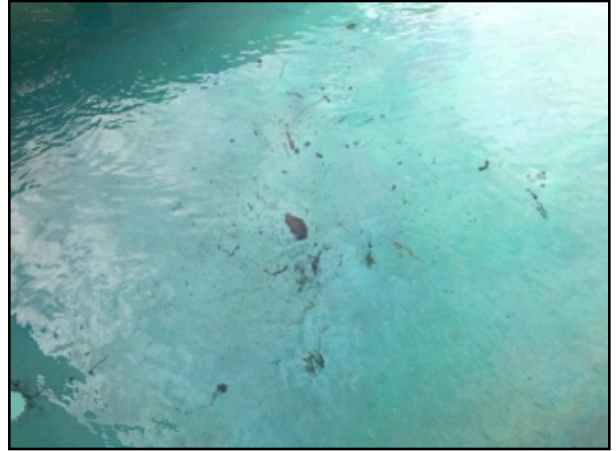
22) The pool interior surface had two large rust stains. This was likely caused by rebar close to the pool surface that had rusted. Recommend further evaluation by a pool contractor for repair of these areas and refinishing of the entire pool finish.

The pool interior surface had two large rust stains. This was likely caused by rebar close to the pool surface that had rusted. Recommend further evaluation by a pool contractor for repair of these areas and refinishing of the entire pool finish.

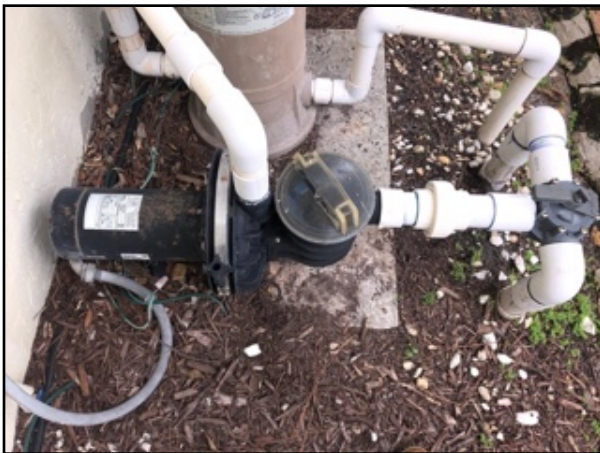
Figure 58-1

23) The motor and pump were working and running during the inspection. The motor was a bit noisy so likely it will need replacement soon. The motor was not properly grounded which would be an electrical shock hazard. Recommend an electrician correct.

The motor and pump were working and running during the inspection. The motor was a bit noisy so likely it will need replacement soon. The motor was not properly grounded which would be an electrical shock hazard. Recommend an electrician correct.

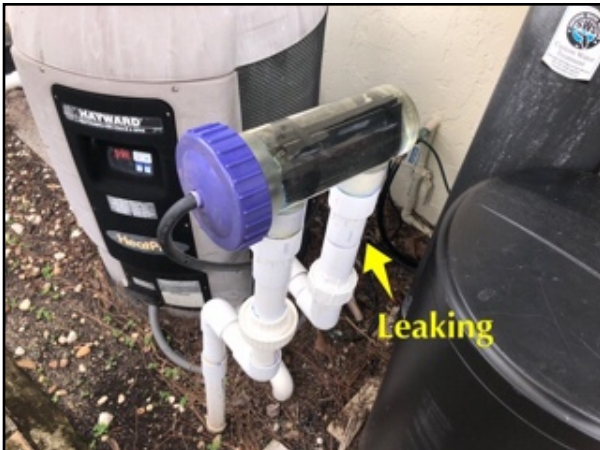
Figure 61-1

There was a small plumbing leak that should be repaired.

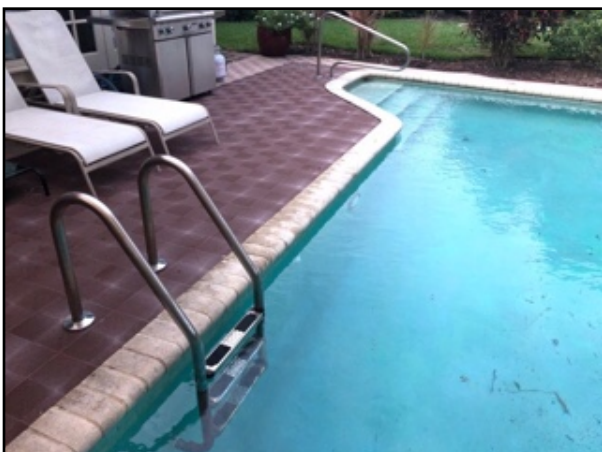
Figure 65-1

24) The pool light did not appear to be working at time of inspection. Recommend repair/replacement by a pool contractor.

The pool light did not appear to be working at time of inspection. Recommend repair/replacement by a pool contractor.

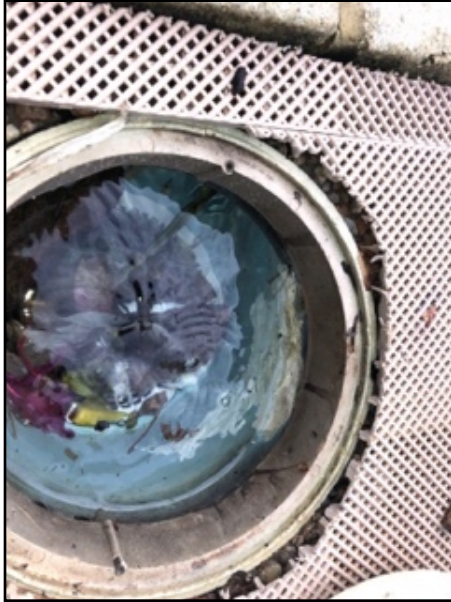
Figure 66-1

25) The pool skimmer had repairs from cracks. Recommend replacing skimmer at time of pool resurfacing and wall repair.

The pool skimmer had repairs from cracks. Recommend replacing skimmer at time of pool resurfacing and wall repair.
