Trapco Inspections, LLC.

Home Inspection Report

1 Main Street

Inspected on Monday, October 19, 2020 at 9:00 am

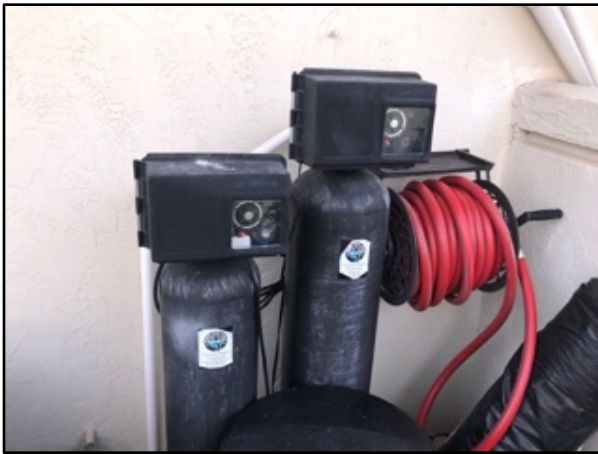
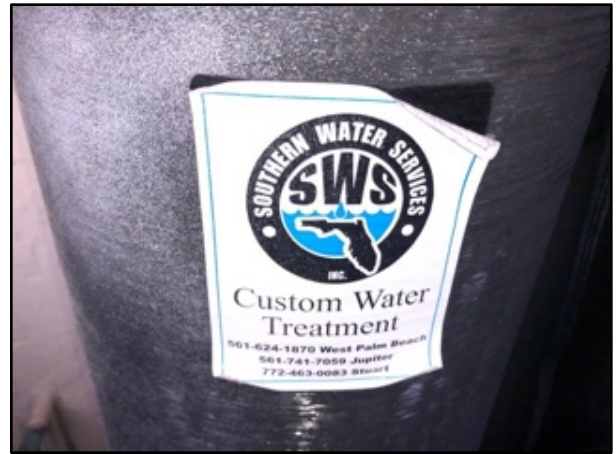
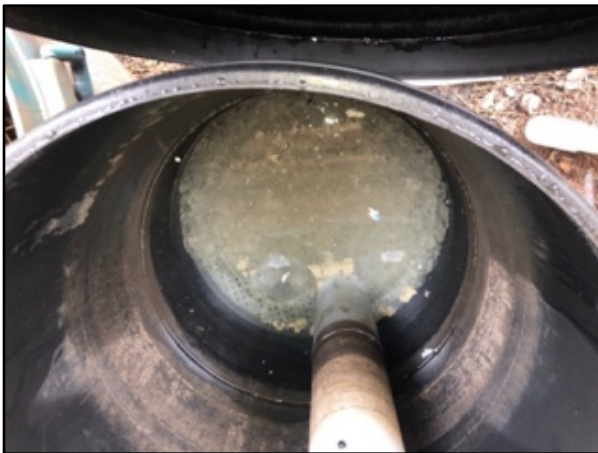
Water filtration systems are not part of a home inspection. No leaks were observed.

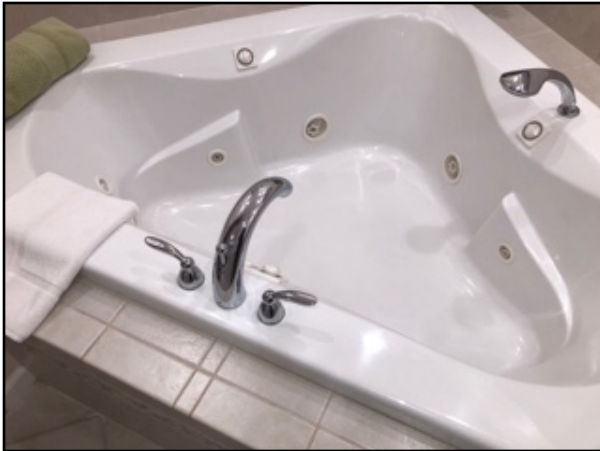
Figure 46-1

Because the inspection was cut short by the seller's agent, the recirculating tub was not run with water in it. The motor did activate when turned to the on position.

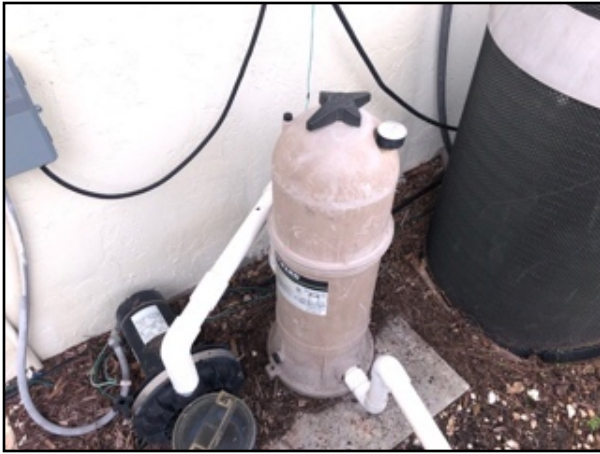
Figure 59-1

The cartridge style filter was functioning at time of inspection.

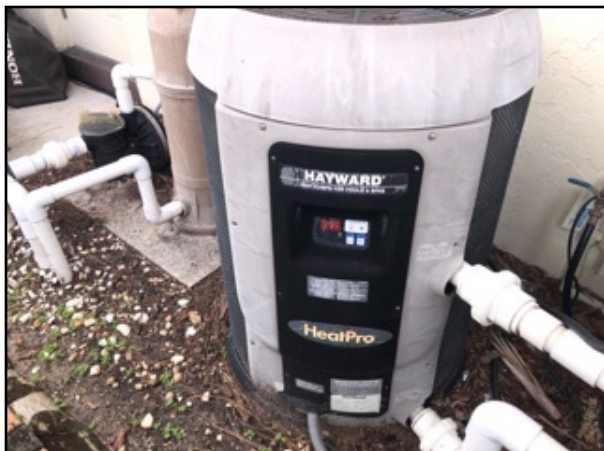
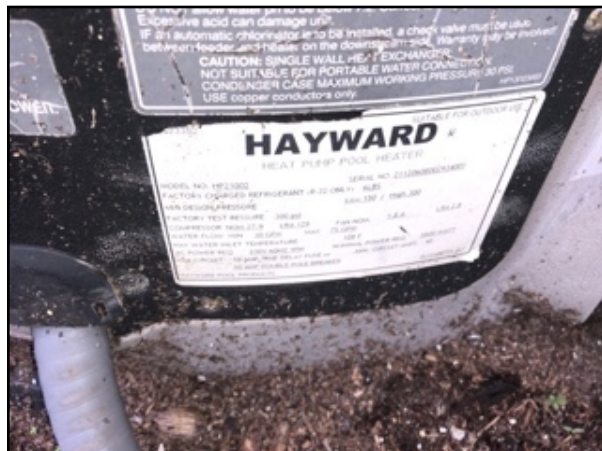
The pool heater was turned on at time of inspection and heating water.

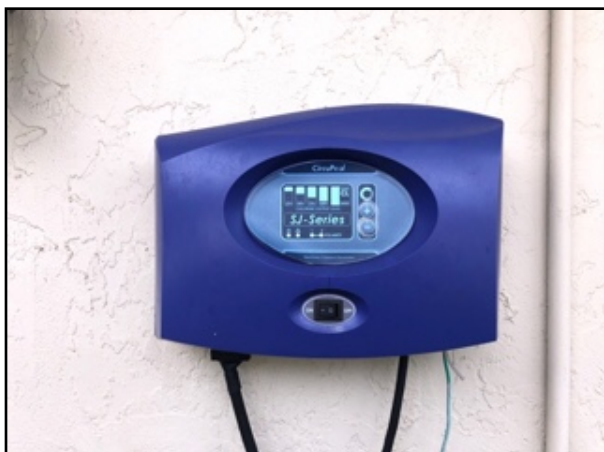
Figure 63-1

Chlorinator appeared to be functioning at time of inspection.

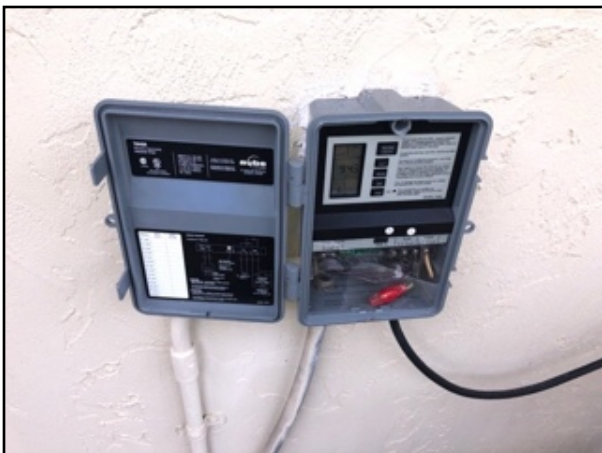
Figure 64-1

The pool timer device was working at time of inspection.
